# Manhole Inspection Summary

Manhole # S33MM\_030MH

Insp Date: **11/28/06 9:34 AM**

**Location** Address: **2200 HOWARD ST**

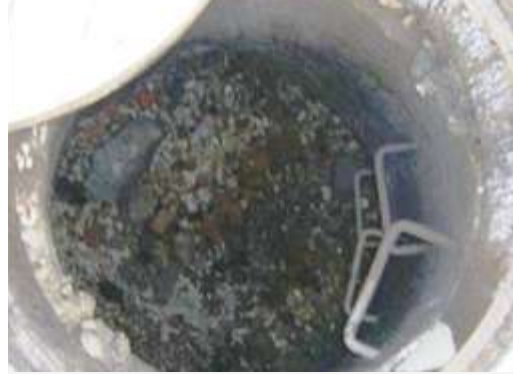
Top View

Barrel infiltration. Channel debris.

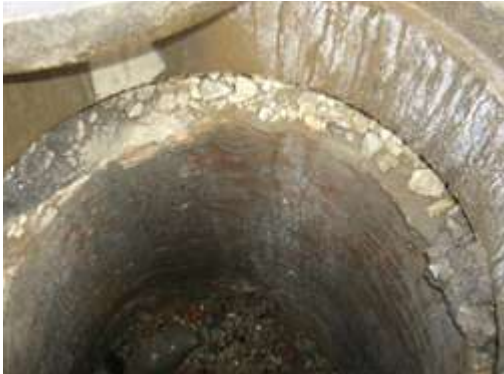
Defect

☒ **Leaks**

Condition: ☐ Sound ☐ Cracked ☐ Root Intrusion ☐ Loose Brick ☒ **Deteriorated**

Infiltration: ☐ None ☒ **Joint** ☐ Cracks ☐ Mortar ☐ Roots ☒ **Wall**

Frame leaks. Frame offset. Adjustment deterioration and infiltration.

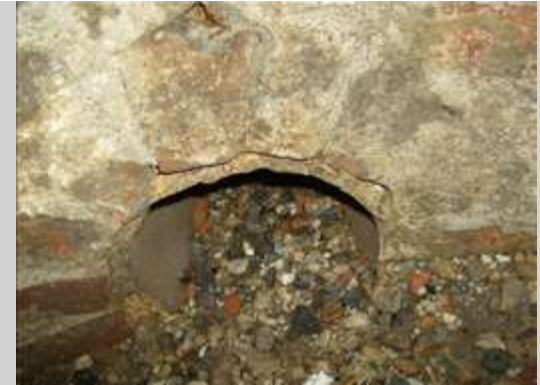
### 8 in. Circular Gravity Sewer Pipe Out @ 12 O'Clock

Deposits: ☐ None ☐ Mud ☐ Sludge ☒ **Debris** ☐ Grease

Silt Depth: **1** (in.) Deposits Extent: **Light**

Infiltration: **Evidence** Pipe Seal Cond: **Unknown**

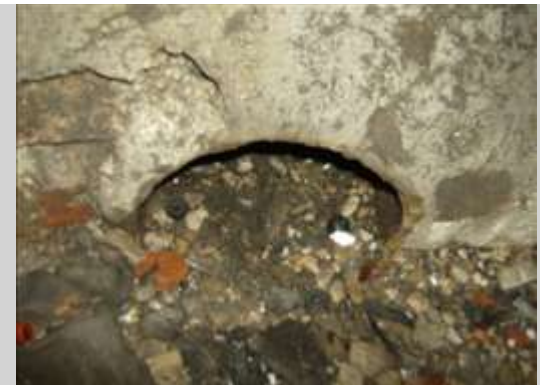
### 8 in. Circular Gravity Sewer Pipe In @ 6 O'Clock

Deposits: ☐ None ☐ Mud ☐ Sludge ☒ **Debris** ☐ Grease

Silt Depth: **3** (in.) Deposits Extent: **Medium**
